Report on Trial Hole Investigations
for
St Saviour's Church
Andrew Granger & Co
on behalf of
The Diocese of Leicester

Issue 01
26/08/2016

I.1 PE Report Reference : STR/IR/KMG/150714/17-2/R003 – Issue 01

I.3 Inspected Property : St Saviour's Church
St Saviour's Road
Leicester
LE5 3HD

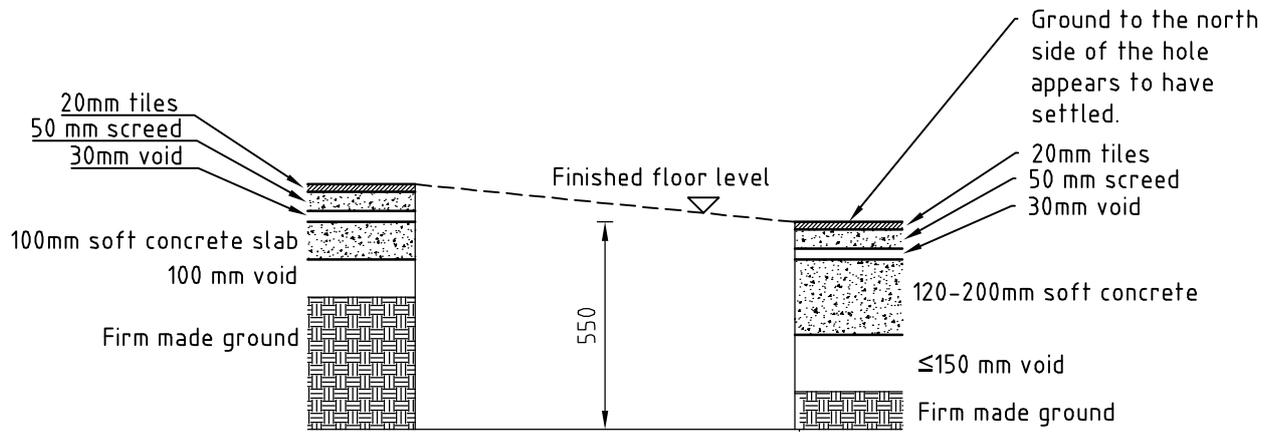
Drawing Title	Status
Trial Hole Investigations	INFORMATION
Trial Pit 1	Scale - unless otherwise stated 1:20 at A4
Drawing Number	Rev
150714/S/004	P01

3.2.1 The construction detail uncovered at Trial Pit 1 (**Photos 1 & 2**) (see drawing 150714/S/004) was a 120-200mm thick ground bearing in-situ concrete slab covered with a 50mm screed and 20mm thick clay tiles. The underlying soil appeared to be firm made ground to a depth of 550mm, where the trial hole was terminated. However, there were large voids of up to 150mm depth observed above and to the underside of the slab (**Photo 2**). Furthermore, the concrete appeared to be soft with large aggregate elements and therefore unlikely to be of structural grade.

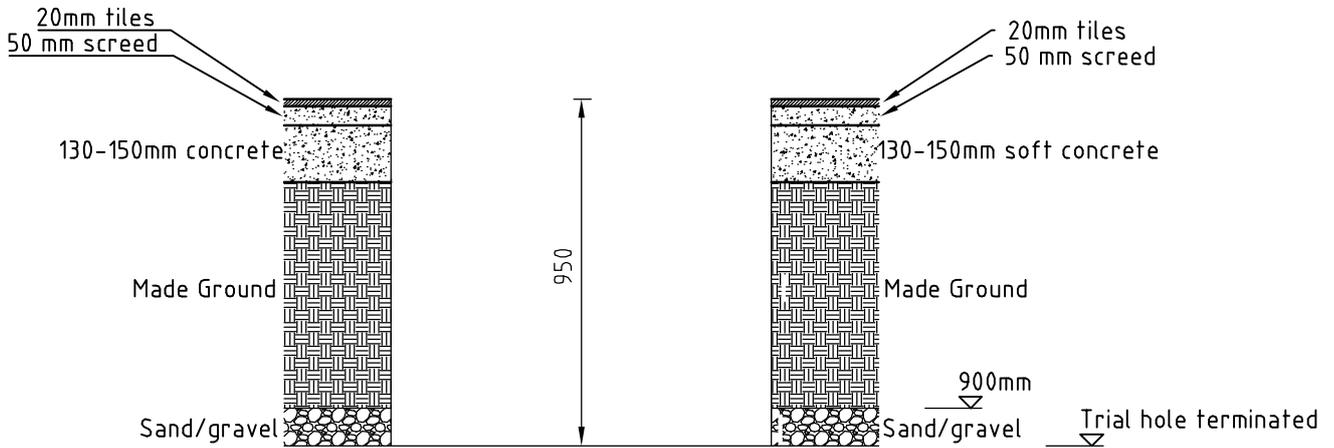
Drawing Title	Status
Trial Hole Investigations	INFORMATION
Trial Pit 2	Scale - unless otherwise stated 1:20 at A4
Drawing Number	Rev
150714/S/005	P01

3.2.2 Trial Pit 2 (**Photos 3 & 4**) had a similar construction detail which was a 130-150mm thick ground bearing in-situ concrete slab, 50mm screed and 20mm thick tiles. The underlying soil appeared to be made ground to a depth of approximately 850mm and gravelly sand to a depth of 950mm at which point, the trial hole was terminated.

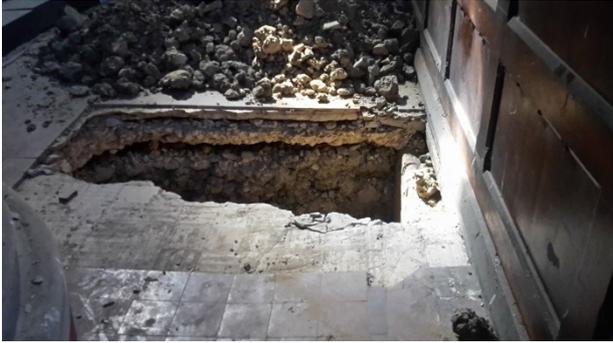
Photo No. 1

- 4.1 There was significant voiding observed above and beneath concrete the slab at Trial Hole 1, which indicates that the made ground has settled and the slab has therefore lost its bearing and also settled. Further settlement might also be expected.

- 4.2 Additionally, the concrete mix used to cast the slab appeared to be very soft and therefore is potentially not a structural concrete grade. Consequently, the concrete mix may not be adequate for the applied loading and is likely to have resulted in the distortions and damage to the pulpit.

- 5.1 Typically, to undertake localised remedial works where the concrete floors have settled, we recommend (at Trial Holes 1 and 2) the concrete slab and underlying soil to a depth of 600mm below the underside of the existing slab should be removed. Then either lean mix concrete or Type 1 granular fill in 4 No. 150mm layers should be used to backfill the area. We would then recommend constructing a new in-situ concrete slab using a GEN 3 (C16/20) mix with dowel reinforcement into the existing concrete. The thickness of the slab would depend on the proposed future use of the building.

- 5.2 An alternative option would be to excavate a series of window sample boreholes at various locations, to confirm the extent and depths of the soil constituents, and to appoint a specialist contractor to provide advice and costings on a suitable ground reinforcement injection scheme to stabilise the settled floor. However, this may not be effective at the location of Trial Pit 1, where the potentially weaker non-structural slab was observed.

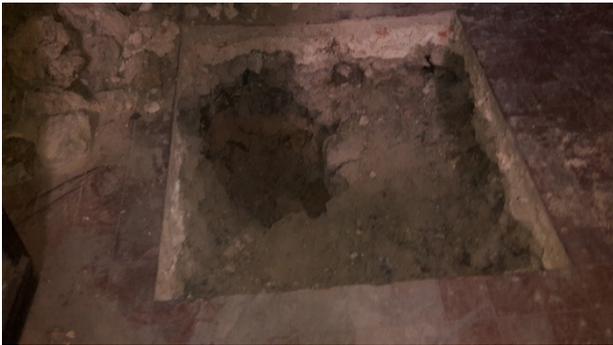
Photo No. 3

- 4.3 The cause of the settlement at Trial Hole 2 was not clear from our limited intrusive investigations. However, made ground with underlying gravelly sand is typically not suitable soil conditions to provide support to a ground bearing concrete slab. The made ground is therefore also likely to have settled, causing the deflection noted in the floor. As with Trial Hole 1, further settlement cannot be ruled out.

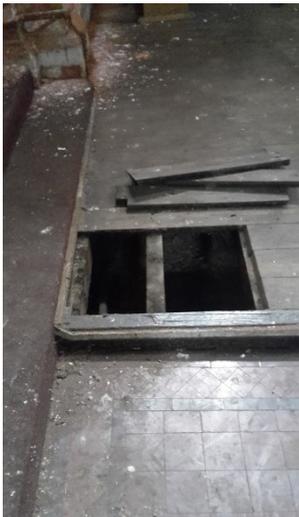
Photo No. 5

3.2.3 Trial Pit 3 (**Photos 5 & 6**) was to determine the detail and condition of the timber floor structure which has deflected. The investigation entailed the lifting of the timber floor boards where a previous access point was present; however, no excavation was carried out beneath. The construction detail uncovered was a suspended timber floor with 110mm x 60mm timber joists at 370mm centres. There appears to be a masonry sleeper wall (**Photo 6**) at the midspan of the timber joists, however, from our limited visual inspection it appears the timber joists are not supported by the sleeper wall, possibly due to a construction defect or settlement. Therefore, the joists could span to the external south wall of the South Transept, which would be a length of approximately 4.25m.

- 4.4 The suspended timber floor at Trial Hole 3 is showing slight settlement at the middle, perpendicular to its span direction. Structural calculations suggest that the floor construction is not adequate to support the loading of a place of worship or domestic property unless the joists are still supported by the sleeper wall at the midspan.

- 5.3 In relation to the timber floor observed at Trial Hole 3, we recommend that further and more extensive intrusive investigations are undertaken to confirm if the sleeper wall is supporting the timber joists and the location of any other intermediate supports. If the joists are found to have no intermediate support provided, we would recommend the sleeper wall is built up with timber packings to ensure it supports the underside of the timber floor joists at the South Transept. We also advise installing a damp proof membrane (DPM) at the top of the brickwork of the sleeper wall to prevent potential future damp penetration to the timber floor.
